TSCA Report

S.J. Nudelman and Son
2707 N.W. Nela Street
Portland, OR 97210

June 13, 1994 11:15 AM

Inspection Authority and Purpose

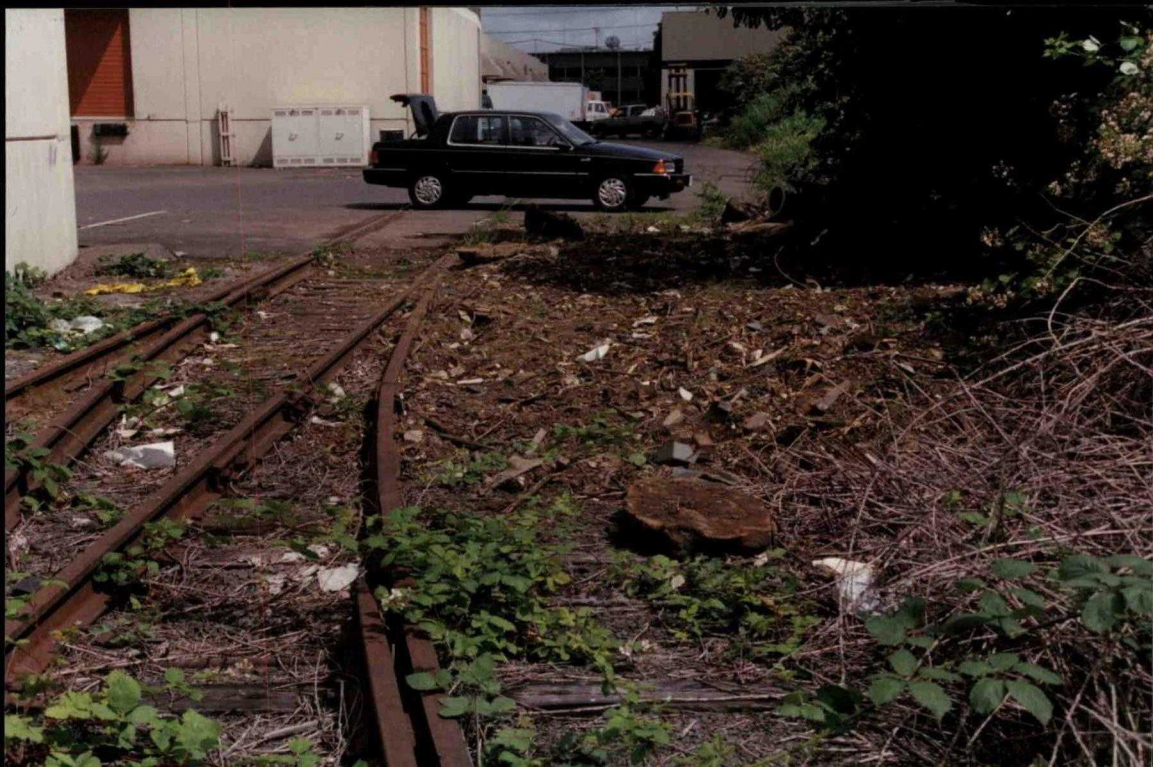
S.J. Nudelman,
Portland,OR, HEISTER,
6/13/94 PHOTO #2

half acres and has a mobile home which serves as the office. We entered the property from the south side. The most distinguishing feature of the property is it is almost completely over run by wild blackberries (Photo #1). Photos #2-#6 show the south end of the property line. Long and I immediately noticed debris along a railroad spur which appeared to have been bulldozed down from the SJNS property line (see photos #2- #6). The debris contained fluorescent light ballasts, small electric capacitors and one medium sized bushing. Long and I looked at the debris more closely and we found that the small capacitors in the debris were marked non-PCB. Other small caps and ballasts were in too poor a condition to identify.

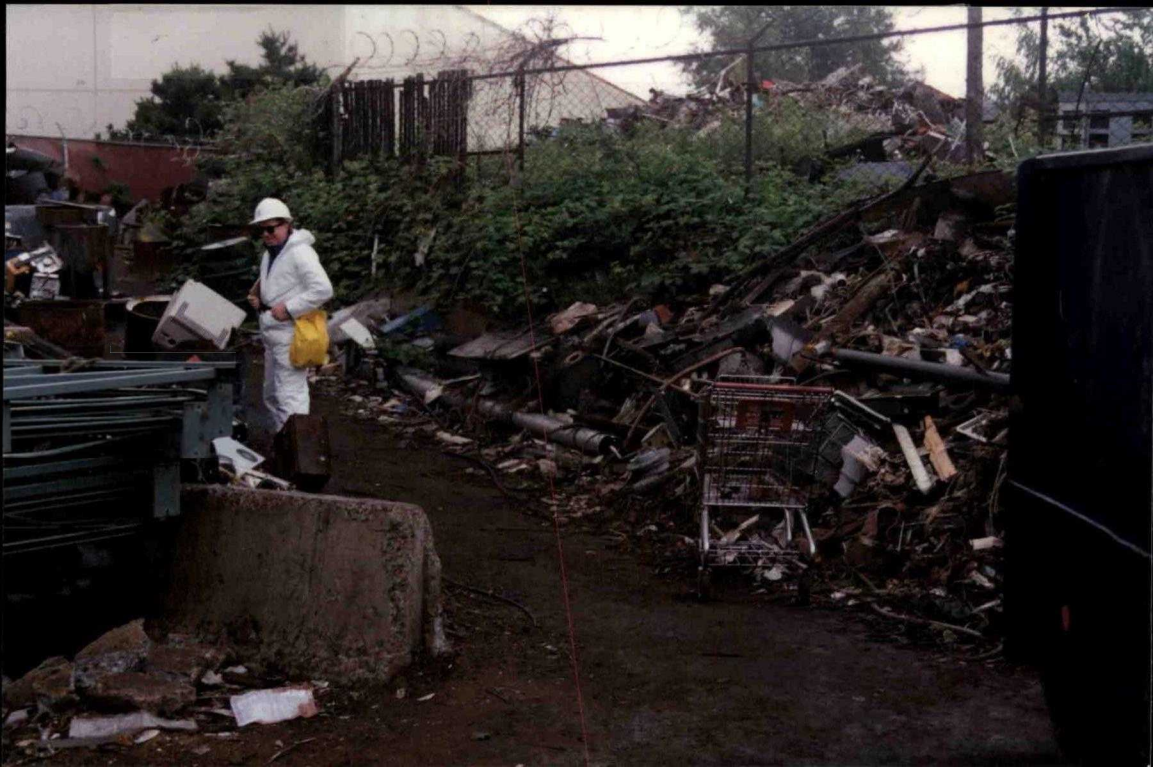
S.J. Nudelman,
Portland,OR,HEISTER
6/13/94 PHOTO #7

Mr. Long and I toured the entire yard but because of Mr. Nudelman's age (76 years old) he requested that his involvement be limited. I said that would be fine. I asked Mr. Nudelman to take us to the site of the fire. He took us directly behind the office to the area seen in Photo #7. Mr. Nudelman said that one of his workers was using a power grinder to cut up metal when some of the sparks ignited the pile seen directly behind Bruce Long in Photo #7. He said that the fire department responded quickly and the fire was out in a matter of minutes, but due to regulation OROSHA was called to investigate. Photo #7 also shows a fence, beyond which was the largest part of the yard. This area held the majority of scrap on the property but was made very inaccessible by blackberry bramble. Mr. Nudelman said we were welcome to examine that area but he would not be able to accompany us. He said that if we didn't need anything else from him he would wait for us in his office. I said that would be permissible.

We next proceeded to the area located directly behind the fence adjacent to the fire area. This area was literally smothered in blackberry bushes and by the end of the tour both my and Bruce Long's Tyvek coveralls were in shreds. This area can best be seen in photo #7 which shows a huge pile of scrap behind the barbed wire topped fence. Atop this pile was the Westinghouse single phase S-Transformer (Serial #72U172) seen in photo #18. The name plate did not indicate the type of dielectric. In retrospect, I took considerable risk to reach this transformer, which was about 20 feet high atop a huge pile of scrap. After having done it once I would not have attempted it again. As best we could tell this was the only visible transformer on the entire pile. Photo #19 shows the pile from the reverse angle of photo #7

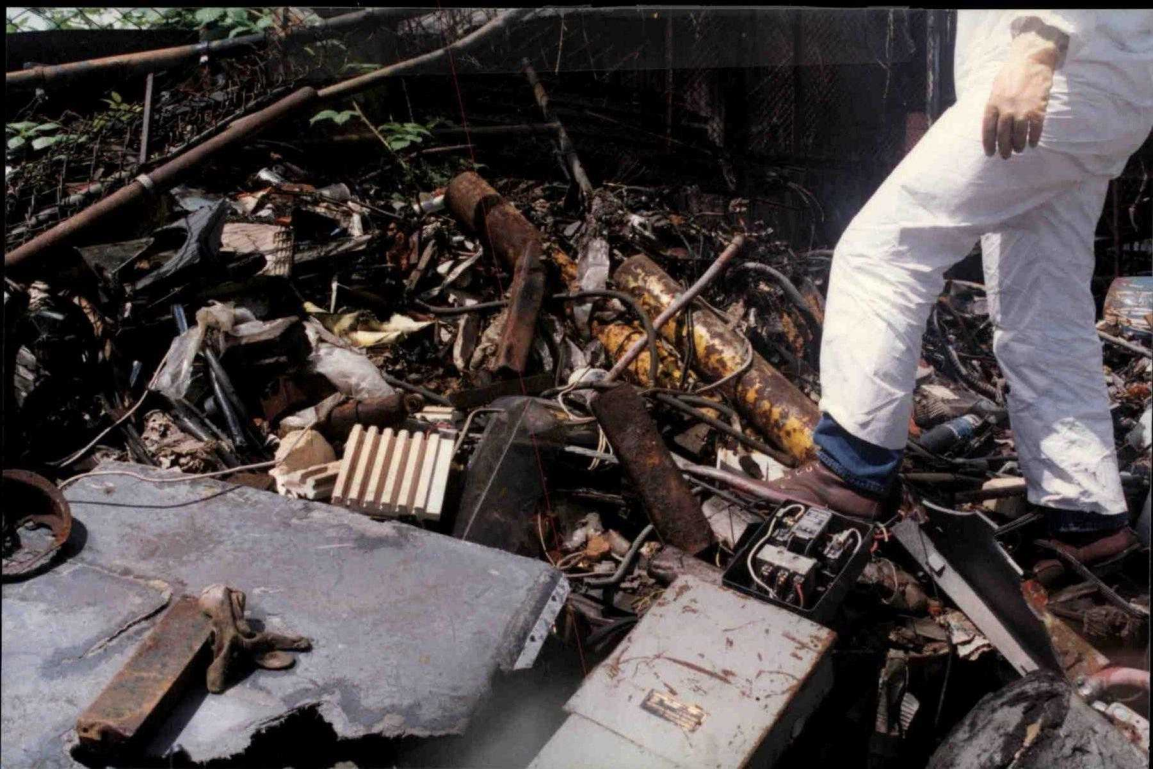
S.J. Nudelman,
Portland,OR, HEISTER,
6/13/94 PHOTO #8

extensive and mostly involved dead blackberry branches and some insulation off of wiring. What was bothersome however was the precarious way things were piled not only in the burned area but throughout the property. As photo #8 shows footing could be quite hazardous and made it difficult to view and inventory the equipment. Mostly what we observed were assumed to be PCB light ballasts like those seen in photos #9-#11 and small scale capacitors like those in photos #12-#14.

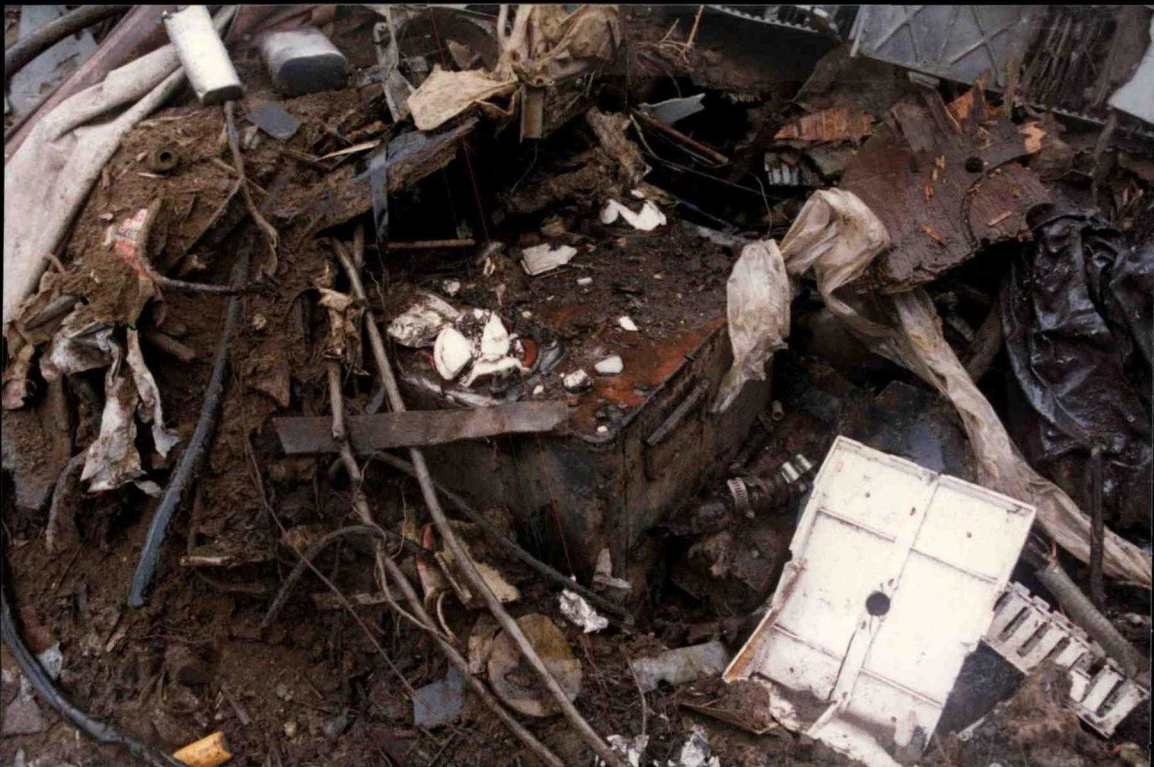
S.J. Nudelman,
Portland,OR,HEISTER
6/13/94 PHOTO #15

We did find a larger piece of equipment in the fire area which was covered by a considerable amount of debris. This unit can be seen in photos #15-#17. The unit was a Westinghouse Potential Transformer Type PTO, style # 1304070-A, Serial #90004. The name plate had no indication of what type dielectric it contained and did not appear to be leaking. The dimensions of the unit appeared to be 12" by 12" by 12".

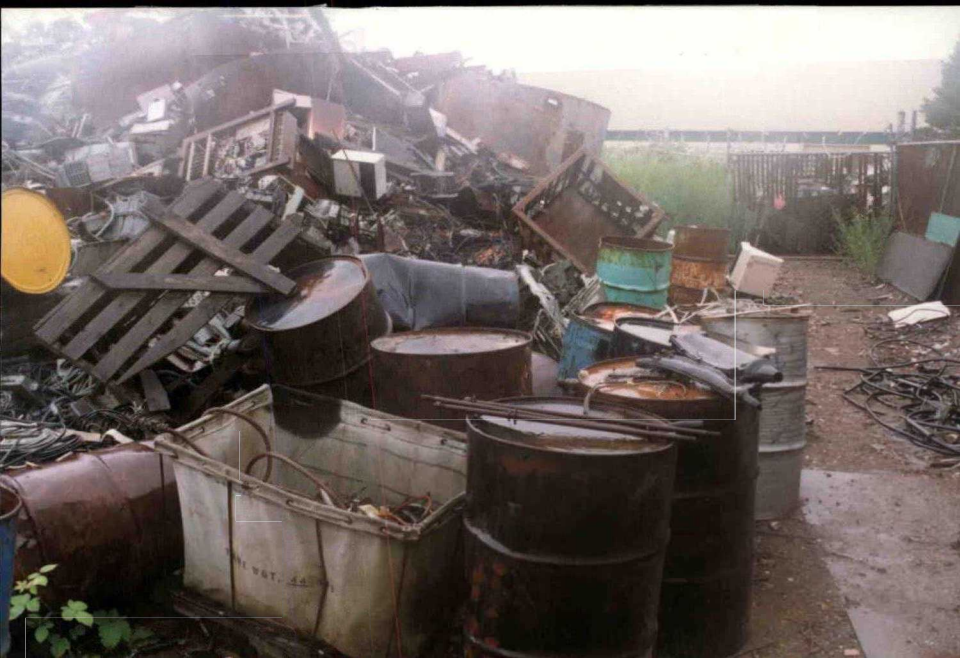
S.J. Nudelman,
Portland,OR, HEISTER,
6/13/94 PHOTO #20

Long and I next proceeded in an easterly direction back into the fenced area. At times it required us to crawl through small tunnels in the bramble. We next came upon the unit pictured in photo #20. This unit was a Westinghouse 30 KVA, 3 phase, type ERT transformer the name plate was badly rusted (seen photo #21) and I could not obtain a serial number. No dielectric type was indicated.
